UNDERWATER BRIDGE INSPECTION REPORT

STRUCTURE NO. 31516
CR 441
OVER THE
MISSISSIPPI RIVER
DISTRICT 1 - ITASCA COUNTY

PREPARED FOR THE
MINNESOTA DEPARTMENT OF TRANSPORTATION
BY
COLLINS ENGINEERS, INC.
JOB NO. 5221 (CEI 8A)

MINNESOTA DEPARTMENT OF TRANSPORTATION
UNDERWATER BRIDGE INSPECTION

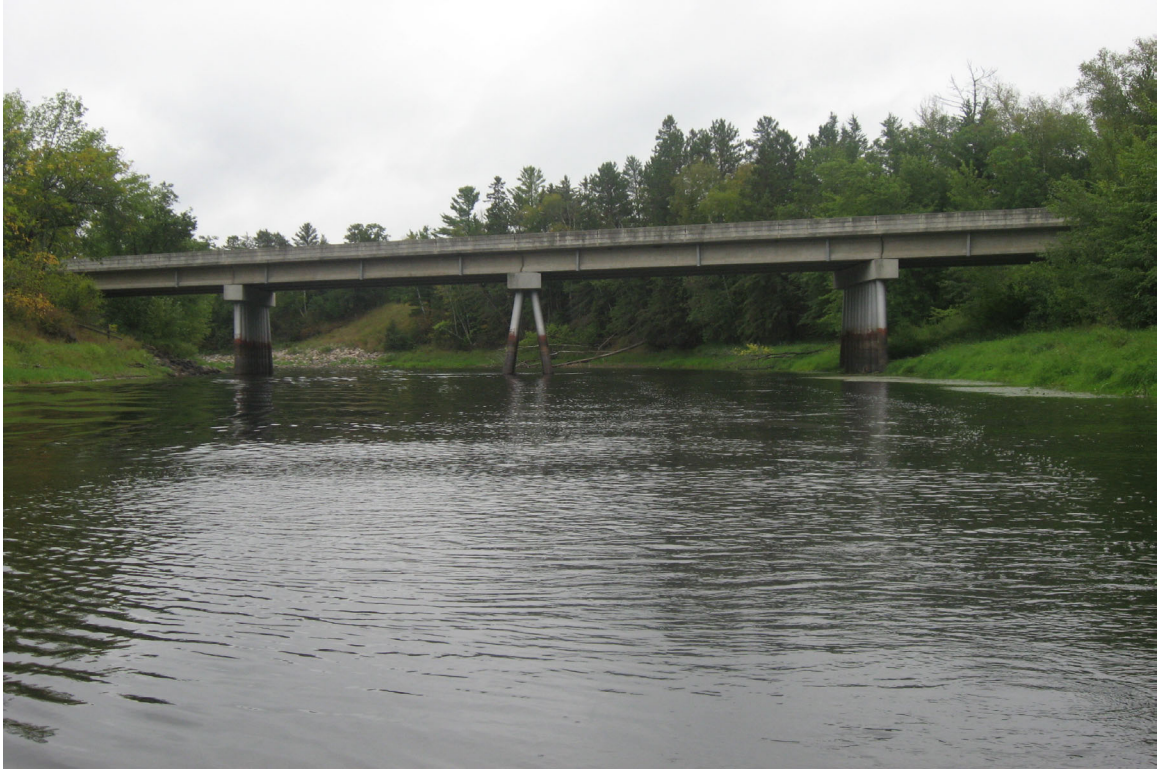
Photograph 1. Overall View of Structure, Looking South.

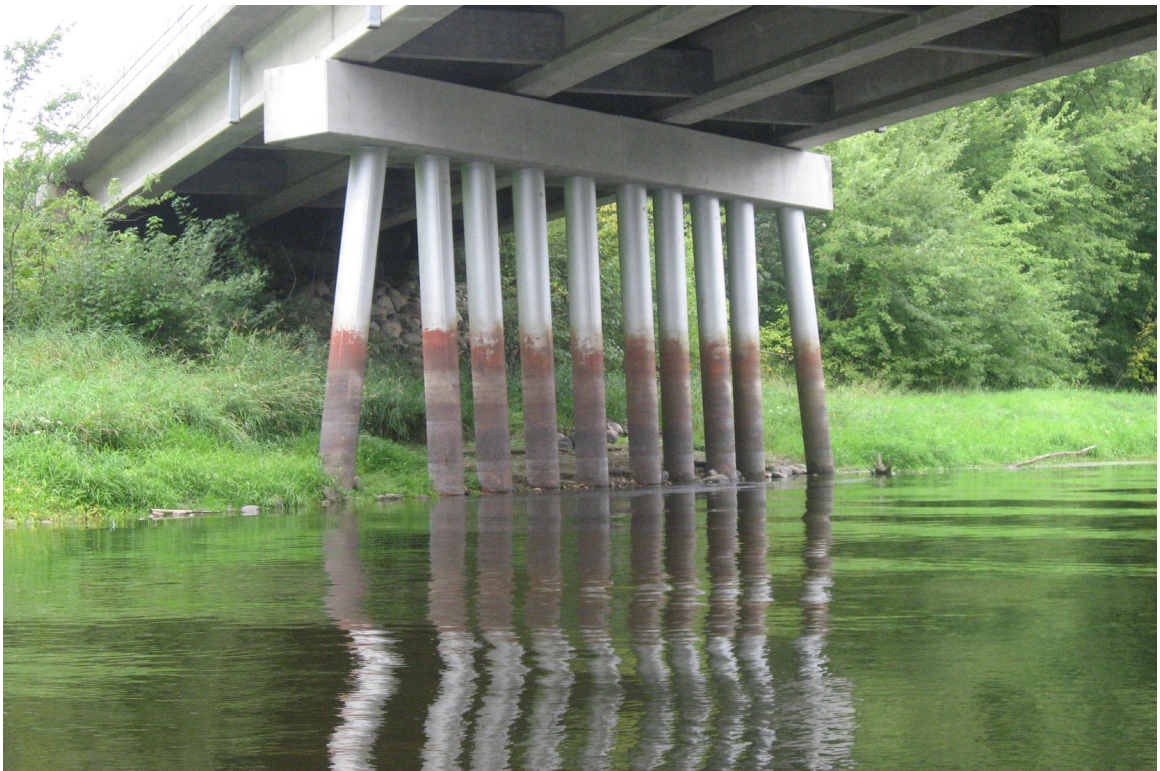
Photograph 2. View of Pier 1, Looking Northwest.

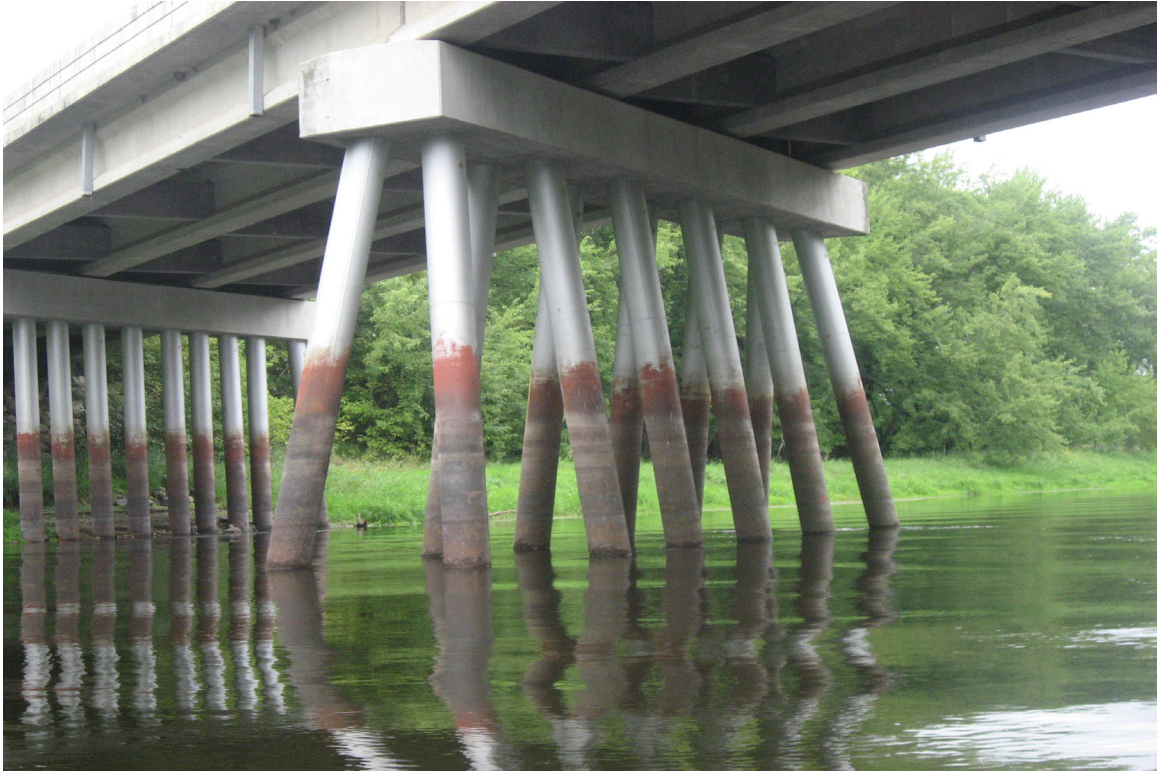
- (C) All piles at Pier 2 exhibited minor scour pockets ranging from 1 to 2 feet in depth and from 1 to 2 feet in radius. At the upstream end of Pier 2 there was a scour pocket 3 feet deep with a 5 feet radius.

- (D) A moderate accumulation of timber debris was observed at the upstream nose of Pier 2 and a light accumulation of timber debris was present at the upstream end of Piers 1 and 3.

Photograph 3. View of Pier 2, Looking Northwest.

- (A) Monitor timber drift accumulations, and if found to be progressing (to an excessive extent in the future), removal may be warranted at that time.
- (B) Reinspect the submerged substructure units at the normal maximum recommended (NBIS) interval of five (5) years.

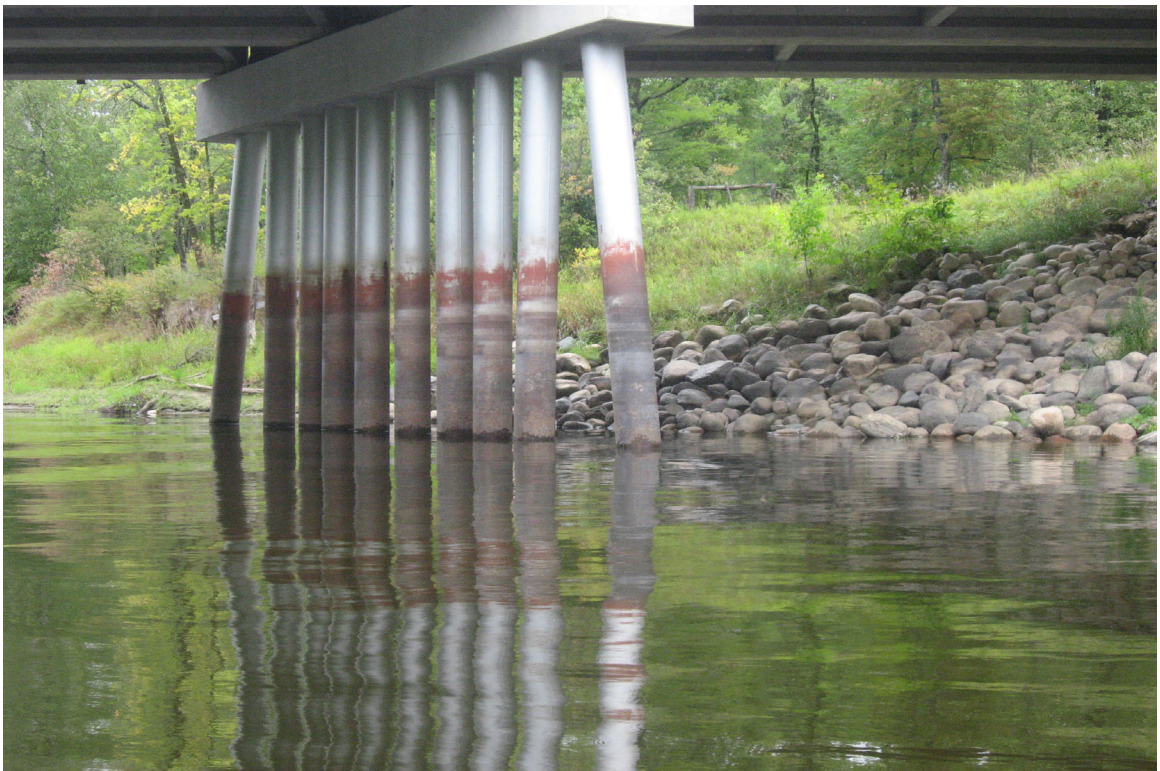
Photograph 4. View of Pier 3, Looking Northeast.

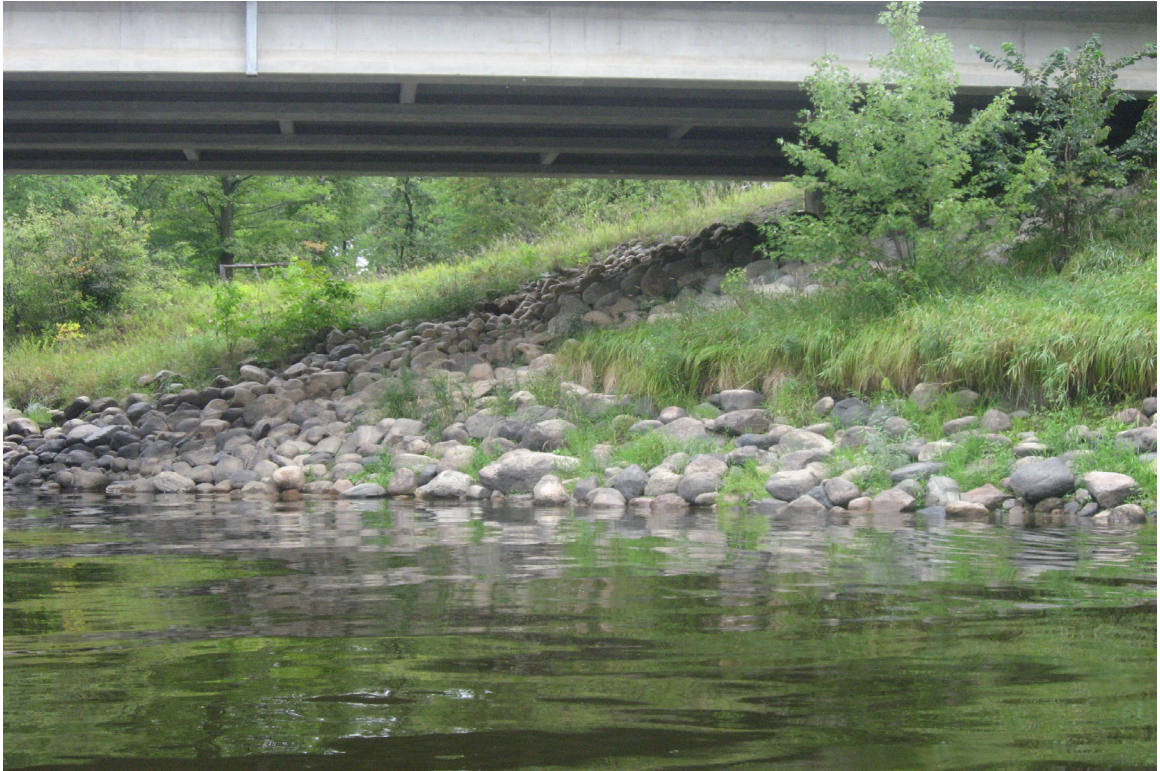
Photograph 5. View of East Embankment looking Northeast.

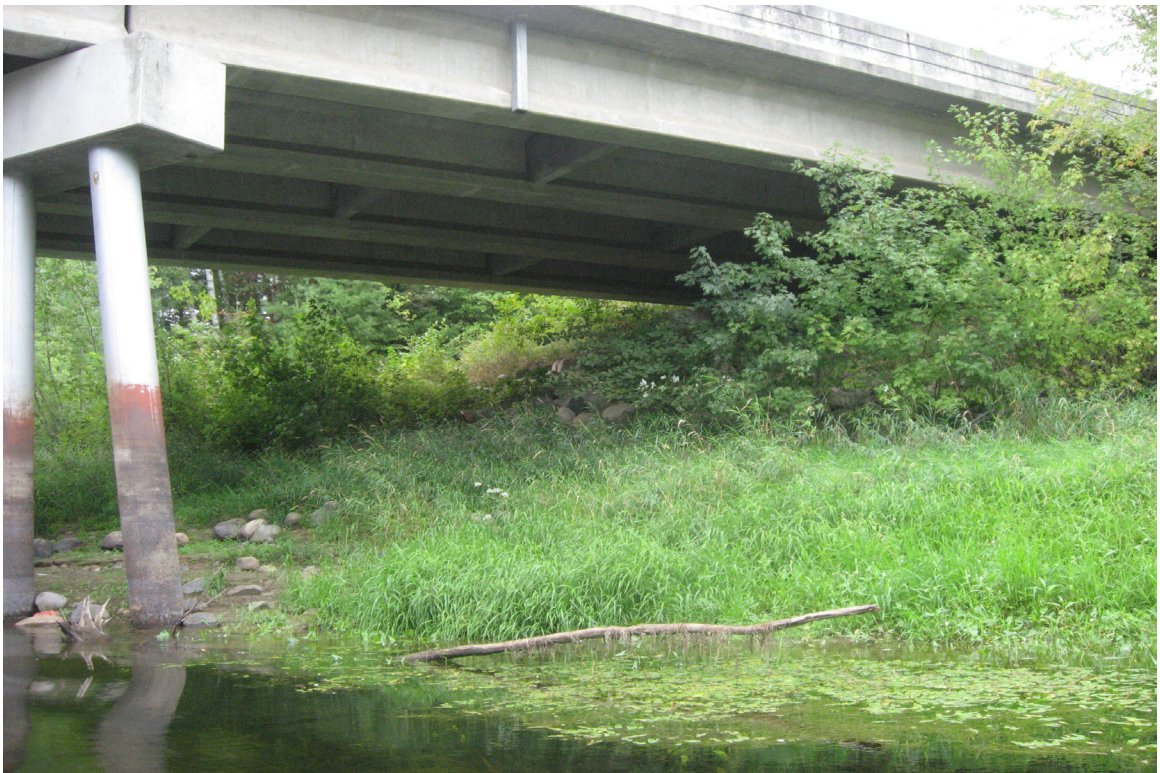
Photograph 6. View of West Embankment looking Southwest.

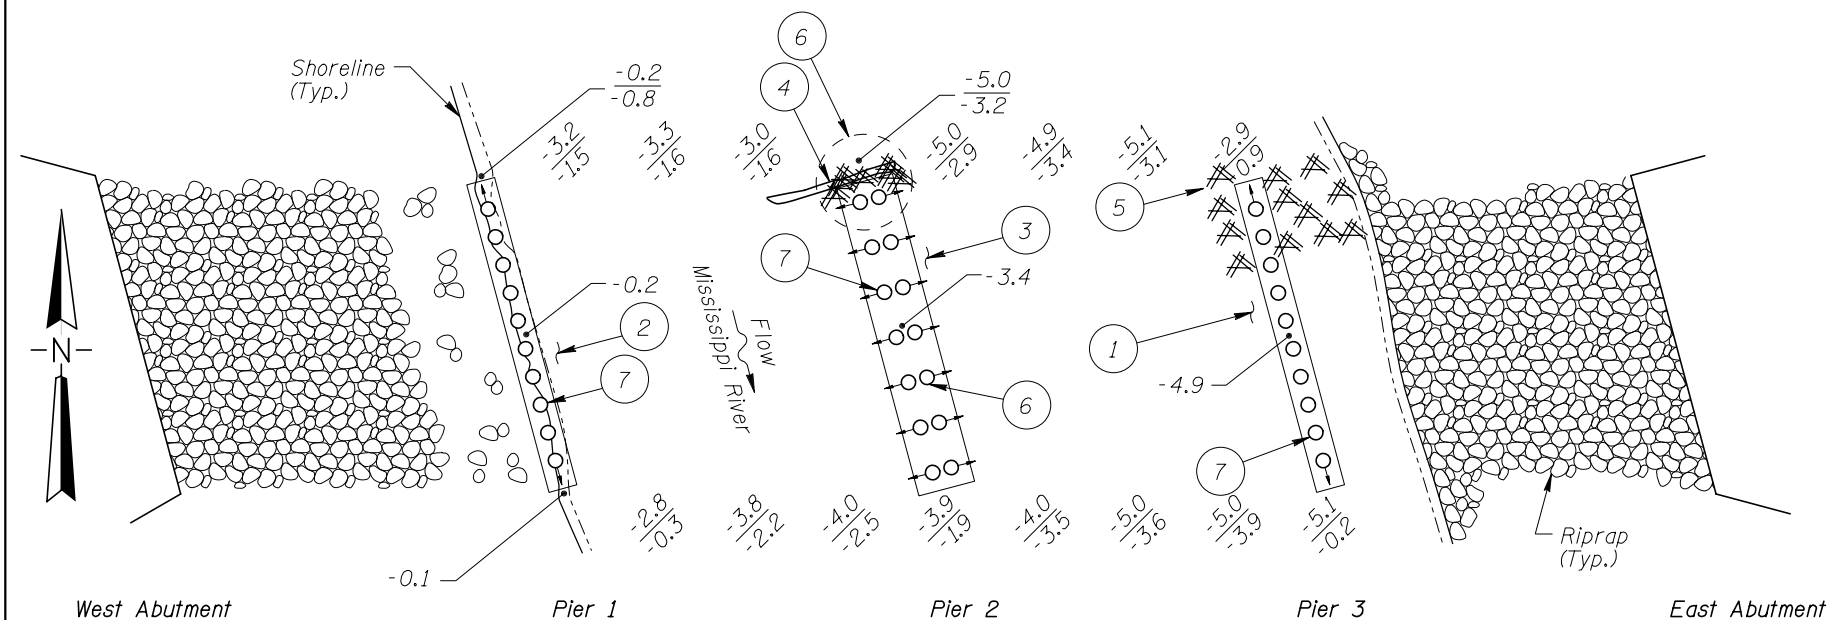
SOUNDING PLAN

- 1 The channel bottom material consisted of firm sandy gravel with cobbles and 1 foot diameter riprap and 2 to 3 inches of probe rod penetration.
- 2 The channel bottom material consisted of silty sand with cobbles and scattered riprap.

- 3 The channel bottom consisted of silty sand with up to 1 foot of probe rod penetration.
- 4 Moderate accumulation of up to 1 foot diameter timber debris from the channel bottom to waterline. Also a 2 feet diameter log across both upstream piles of bent 2 that extends off to the West of Pier.

- 5 Light accumulation of timber debris consisting of 6 inch diameter and smaller logs and branches from the channel bottom to 2 feet above the channel bottom around upstream piles and mostly along shoreline.

- 6 Minor scour pockets, 1 to 2 feet deep with 1 to 2 feet radius, were observed at all piles. A upstream end of Pier 2 scour was 3 feet deep and 5 feet in radius.

- 7 Steel pipe piles exhibited 100% coating failure from 8 feet above the waterline to the channel bottom with 50 to 100% coverage of typically 1/4 to 1/2 inch diameter rust nodules and up to 1 1/2 inch diameter rust nodules from the waterline to the channel bottom of Piers 2 and 3. From 4 feet above waterline to waterline corrosion was moderate with delaminations and pitting 1/16 inch to 1/8 inch maximum in depth. From waterline to channel bottom there was minimal loss of section with pitting that was typically 1/32 inch to maximum 1/16 inch deep.
